# “The Black/ Fitzhenry’s Castle” Clonmines Wexford ‘Garderobe Chute’

*Proposed structural repair/restoration of  
garderobe chute opening – East Elevation*

**SMR No.: WX045 - 012001**

**10<sup>th</sup> October 2014**

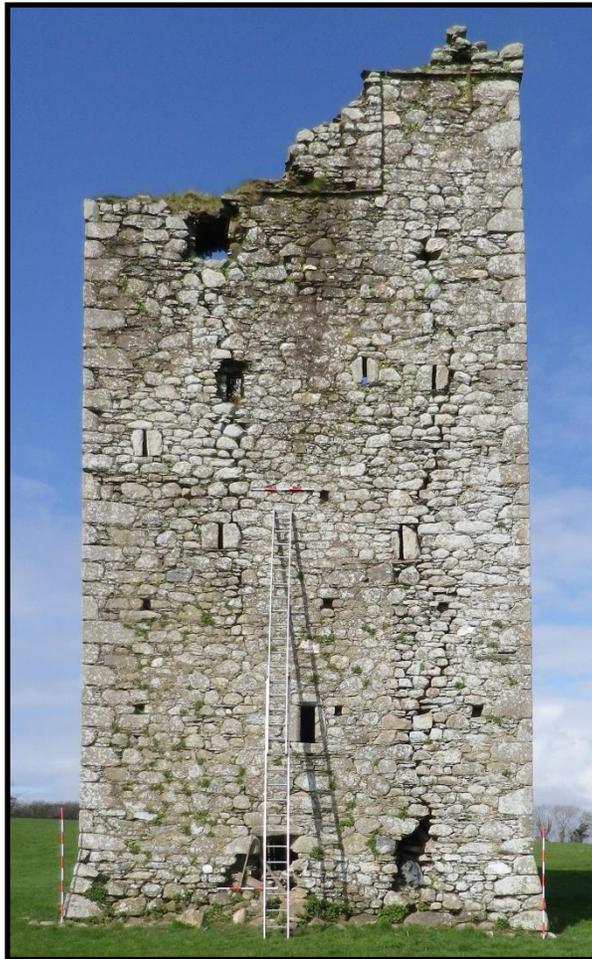
**Figure 1. East Elevation “Black Castle”, Clonmines, Wexford.**

**Scale bar is in 20cm segments. (Photo: Author)**

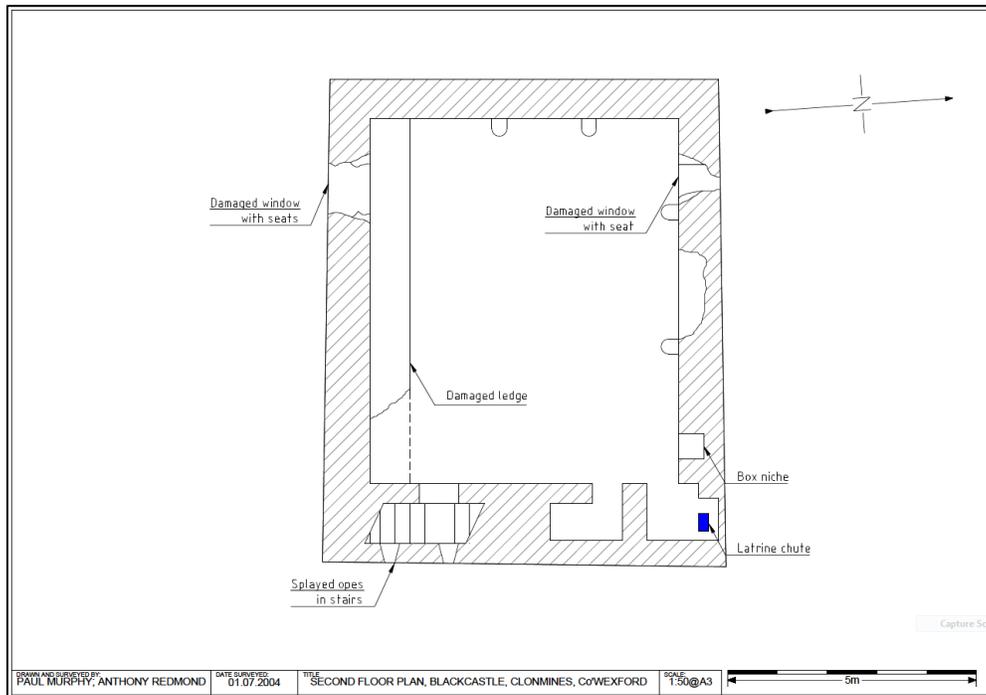
Figure 4. Second Floor Over Vault (garderobe/latrine chute marked in blue).

##### **2<sup>nd</sup> Floor over Vault (Appendix 2, fig. 4 – Floor Plan)**

The floor is accessed from stairs in the E wall, which is entered at the S end (int. dims. 7.32m E-W; 6.19m N-S). It has windows with seats in the N and S walls, and a destroyed fireplace in the N wall. There are two chambers in the E wall each with their own lights. The floor was supported on corbels in the E and N walls, with a rebated ledge on the S wall. The chimney flue is supported on corbels on the outer face of the N wall from this floor.

The chamber in the N is a garderobe (int. dims. 1.16m E-W; 1.43 N-S) – see Appendix 5, fig. 10. The entrance is marked at A 2. The chute at this point is located towards the N wall and is 0.34m (E-W), 0.20m (N-S). fig. 11 D shows the chute opening visible from the floor below. The chute widens N-S down to the 1<sup>st</sup> Floor over vault discharge (fig. 11. Da).

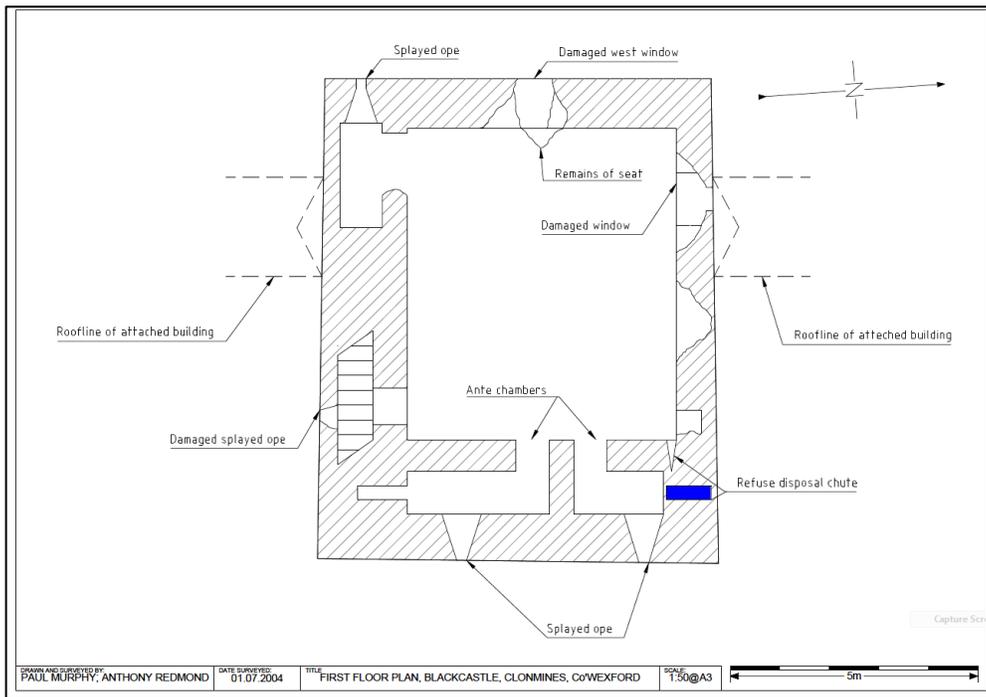
Figure 5. First Floor Over Vault (garderobe/latrine/waste disposal chute marked in blue).

### **1<sup>st</sup> Floor over Vault (Appendix 2, fig. 5 – Floor Plan)**

The floor is accessed from the stairs in the S wall at the SE angle, where a damaged doorway (Width 0.74m) gives access to the first floor over vault (int. dims. 6.3m E-W; 4.34m N-S). This floor has a damaged window in an embrasure with seats in the W wall, and a damaged window and robbed fireplace in the N wall. There are corbels for the ceiling in the W and N walls with a rebate on the other walls. There is a corner chamber (int. dims 2m E-W; 0.86m N-S; H 1.9m) in the thickness of the S wall at the SW angle. There is another chamber (int. dims 2.53m N-S; 0.85m E-W; H 1.93m) at the S end of the E wall.

The garderobe (int. dims 1.8m N-S; 0.86m E-W; H 2.2m) is situated at the NE angle in the thickness of the E wall (fig. 10). The entrance is marked as A 1. It is entered through a lintelled doorway (Width 0.66m; Height 1.85m) in the E wall.

There is a box-niche from the main chamber, which accesses the garderobe chute directly for the disposal of waste (fig. 10. B 1; fig. 11 B). There are no visible remains of a latrine seat, though the walls appear to have been robbed-out (fig. 10). The chute at the floor level extends from the N wall to the S (0.40E-W at S end; c.1m N-S). The chute widens to the S, from the N wall, and continues straight down to the base batter level (fig. 12 – visible from the floor below).

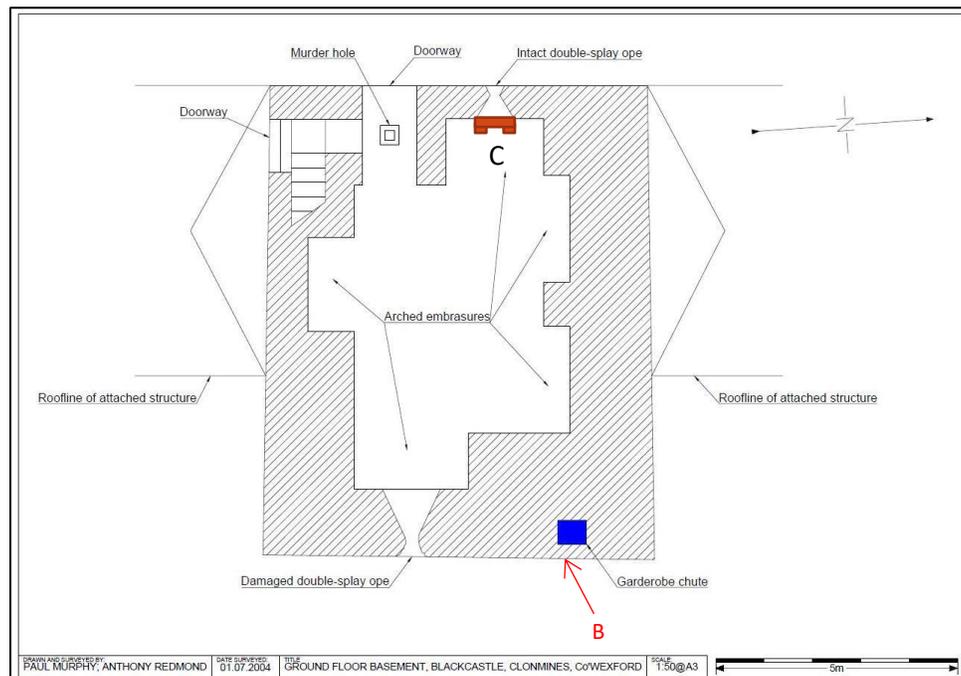
Figure 7. Ground Floor (garderobe/latrine chute marked in blue).

Below the W loop (approx 0.85m) there is a drain opening, with a lintel, which extends all the way beneath the thickness of the base batter (approx. 1m), though blocked on the outside of the W face as it lies below the ground surface and W door lintel level by approx. 0.25m (fig. 7 – on plan in red, marked C & fig. 16, I).

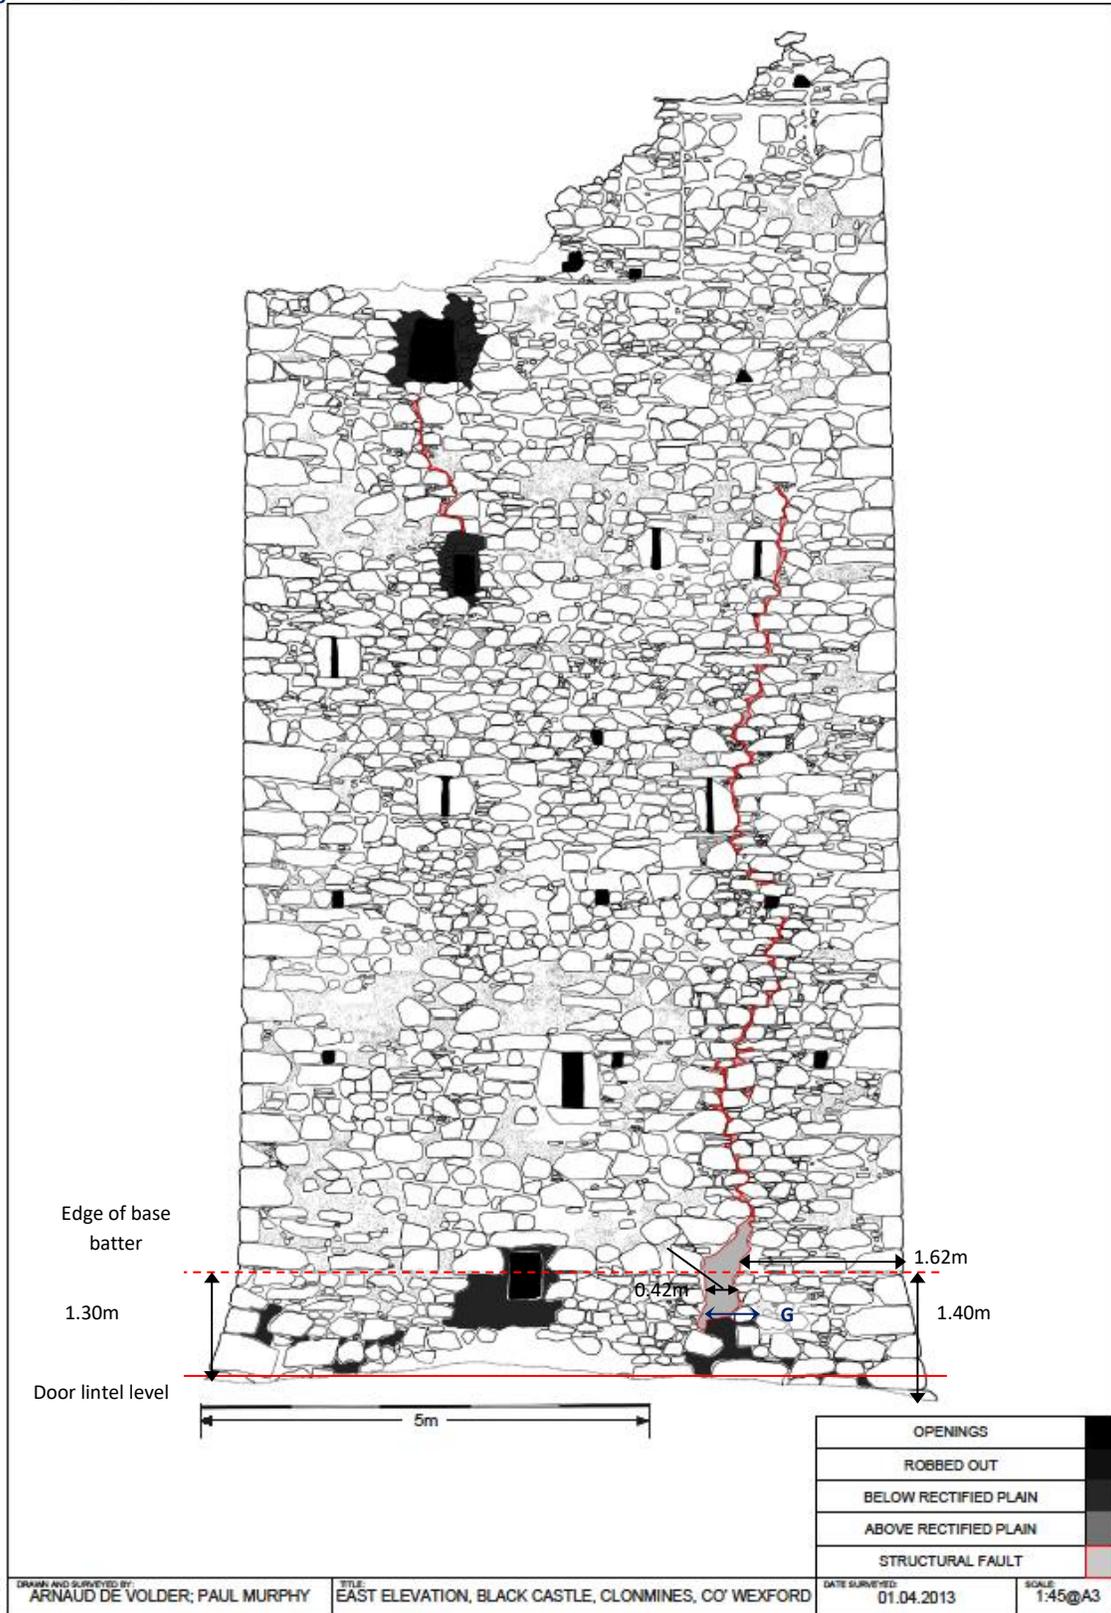
Figure 8. East Elevation

Currently, the apparent chute exit is situated on the east elevation (fig. 8 – the location of the chute, width and the visible base level is marked in blue at G), at a height of approx. 0.75 – 0.80m above ground level (fig. 17 & 18). The opening appears to be robbed-out, and there is a fracture which extends along the line of the chute (fig. 8) to at least 2<sup>nd</sup> floor over vault height. The apparent exit shows no sign of any lintel. The fracture opening is approx. 0.42m at its widest point and approx. 0.80 – 1m high.<sup>4</sup> As is shown in fig. 17, 19 and 20 the chute at this level is filled with loose rubble (J)<sup>5</sup>, and the line of the coursing of the batter and chute appears to have been

As illustrated in fig's. 8, 13, 17 & 18 the level of the base of the chute Gb, as it appears in the fracture, lies currently at approx. 0.75m – 0.80m above the lintel of the door/entrance on the western side of the tower, significantly above ground level.

4. The proposed reconstruction of a discharge opening at the level of the fracture as it currently presents itself is not recommended as it is the conclusion of the author that the original discharge lies at least approx. 0.75m below the current base of the opening.

It would be advisable therefore to consolidate the fracture, closing it up again to prevent access into the chute at this level. The landowners have furthermore expressed concern about their livestock and people getting into the chute. It is recommended that the fracture is closed in such a way that the reconstruction is identifiable.

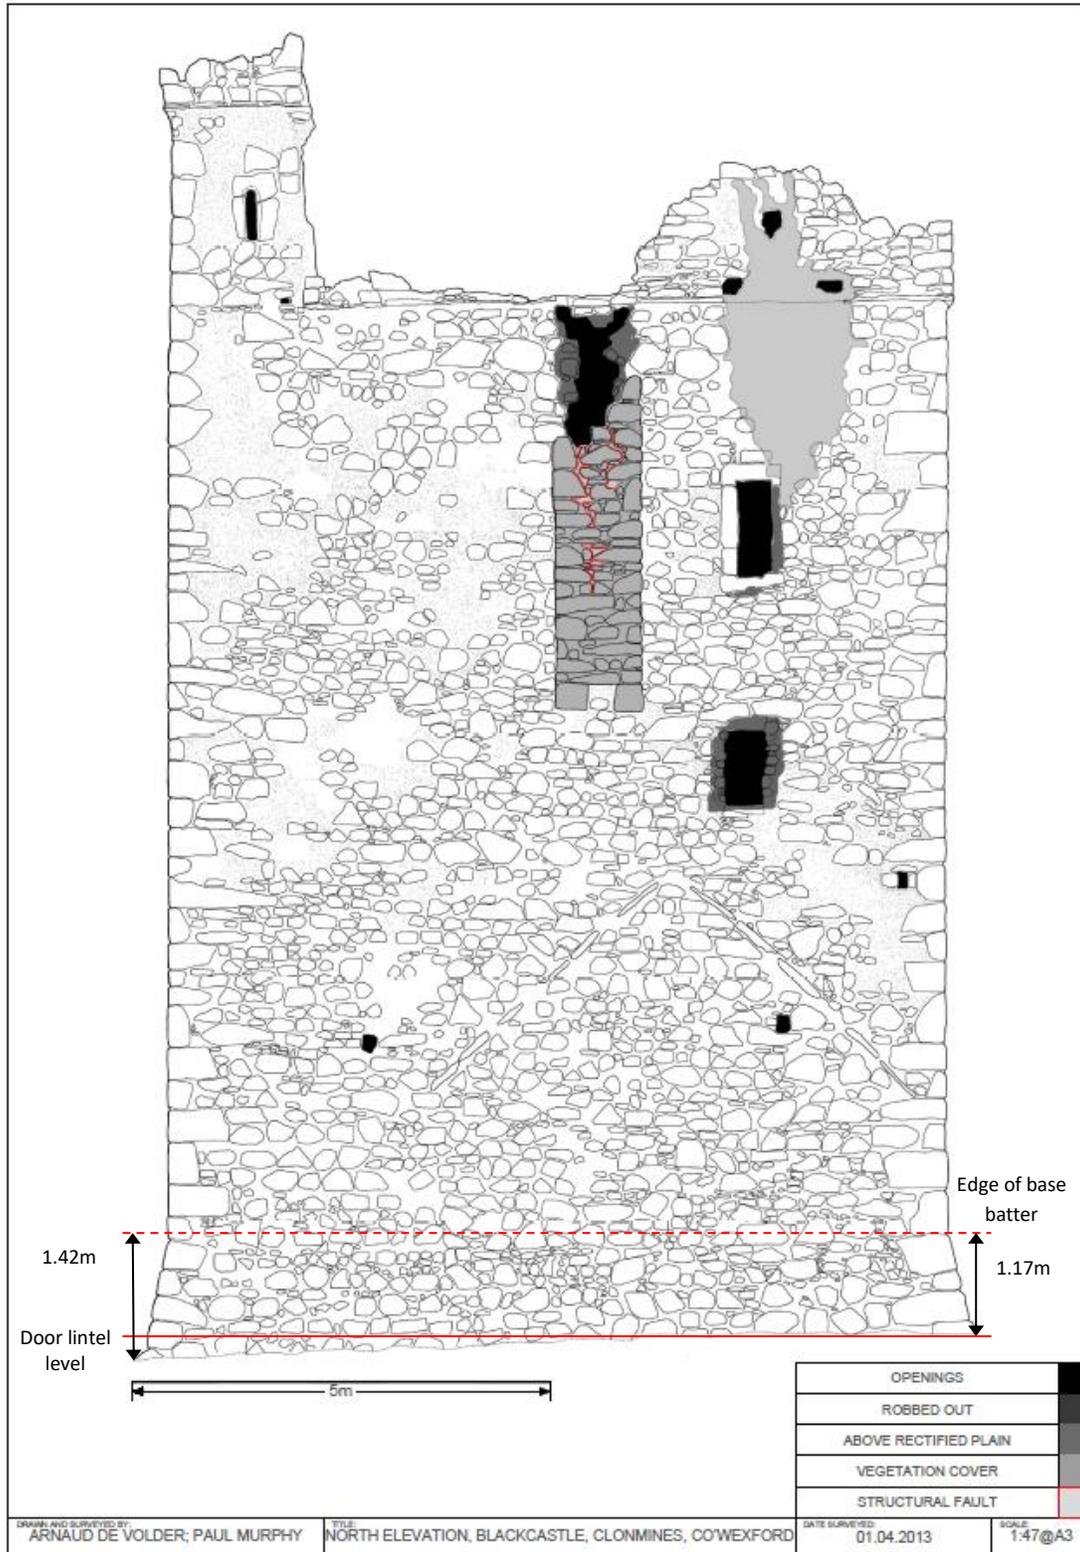
Figure 9. North Elevation

It should be noted that there has been some soil build-up on the E. (and W), but as is illustrated the site slopes from W-E by at least 0.30 – 0.50m currently (fig. 3 illustrates the general slope of the site W to E.; Fig. 9 the slope W to E is visible in relation to the horizontal edge of the base batter on the castle and the ground/lintel level marked in red). This would obscure the discharge, and the drain, at this level. As is often the case the natural slope of the location

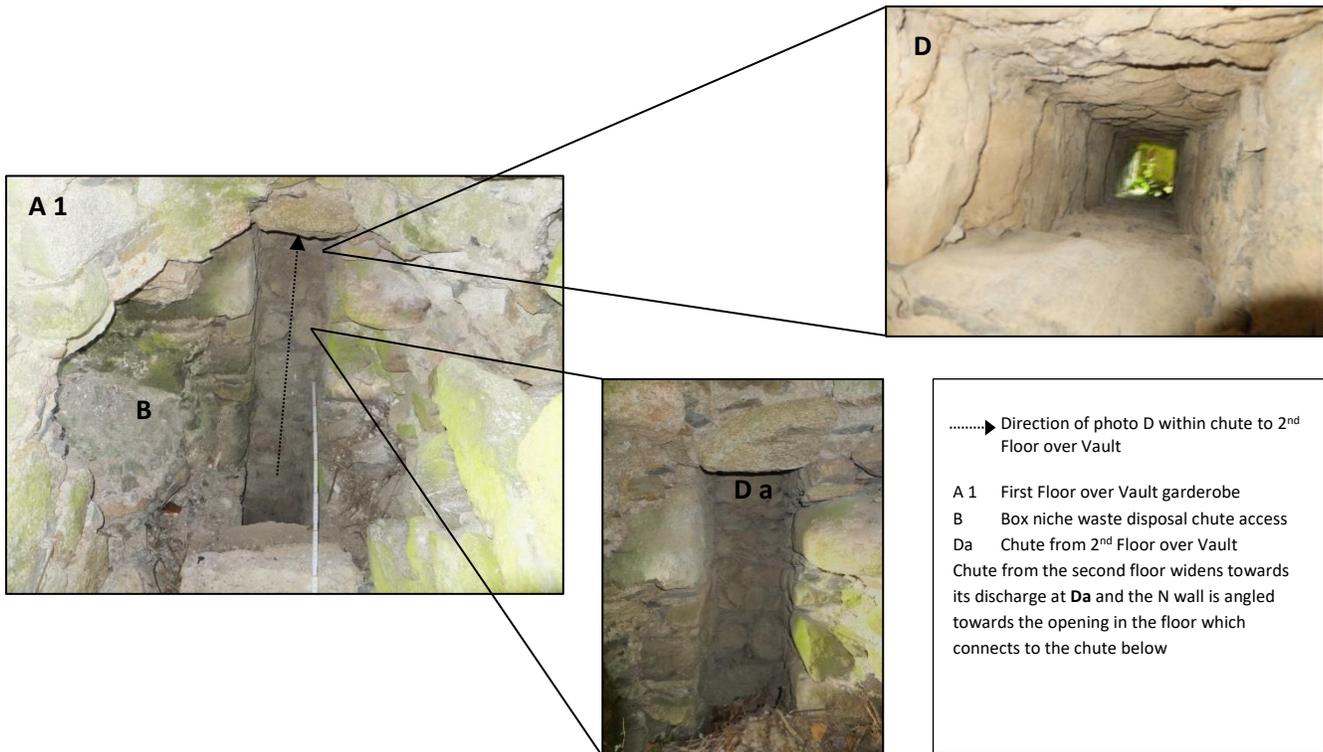
Figure 11. First Floor over Vault garderobe looking north. (Photo's: Author)

The discharge from the floor above exits in the N wall, which is angled towards the south and is lintelled (fig. 11, A1; Da).

There is the possibility that what is described as a garderobe is in-fact a waste disposal chute, as the evidence for latrine seats is missing, though the walls have been robbed out in the chamber on the first floor over vault (fig. 11). There is also the “*slop*” niche box access from the main hall, which adds to this possibility, as how it could have functioned with a seat arrangement in place is not clear (fig. 10 & 11 marked - B). In terms of dating the tower this is an interesting feature as Sweetman has pointed out that garderobes were being replaced by the use of chamber pots at a later period, the contents of which were then sometimes disposed of into a waste-disposal chutes (as there is no evidence of seats), which then went straight down to ground level to exit the building “as if it were a garderobe”. This is before garderobes were generally replaced by the use of chamber pots in 17<sup>th</sup> century fortified houses (2005, 165).

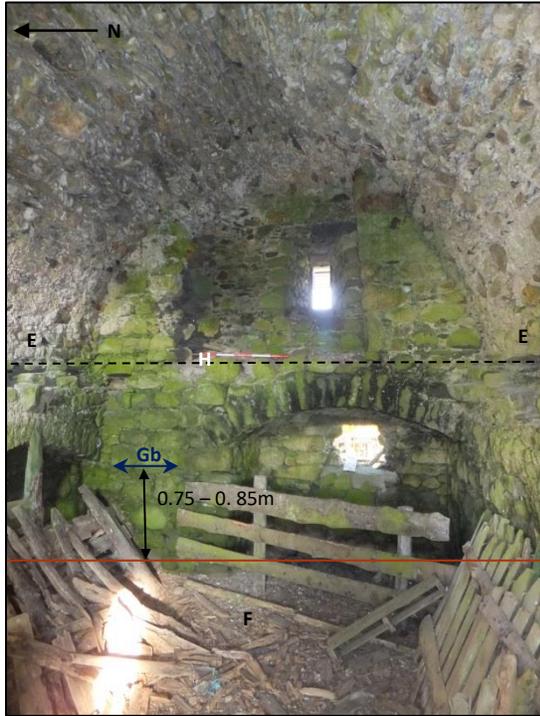
**Figure 12. Chute looking down towards Ground Floor from the First Floor over Vault - the opening in the East Elevation is visible to the right.**

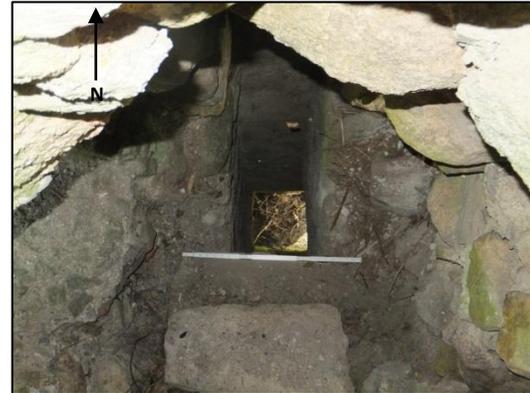
**Figure 13. Ground Floor and Loft (looking east).**

- E** Approx. Loft floor level ----
- F** Lintel level: current floor surface lies 0.25m below the lintel level
- Gb** Approx. level of the bottom edge of the garderobe chute visible in the east elevation fracture (see “G” in fig. 8)
- H** Loft under Vault opening into garderobe chute (robbed out)
- Approx. ground floor/lintel level

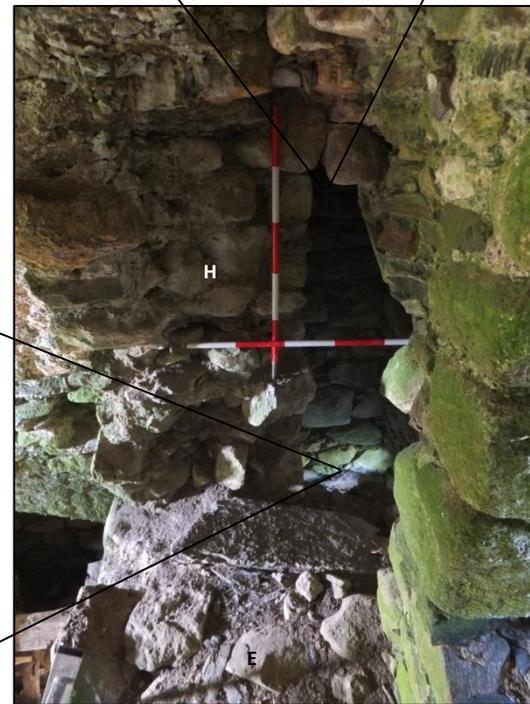
**Figure 14. Robbed out chute opening (Ground Floor Loft).**

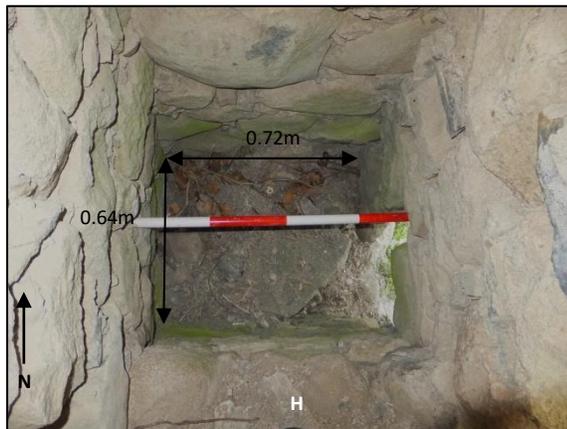
The opening is also off-center, to the S side, of the actual chute within the base batter (see fig. 15, and Appendix 7), and there is no edge to the interior chute coursing visible to indicate an opening, but rather there is evidence that it has been removed.

**Figure 15. Chute looking from Ground Floor Loft. (Photo's: Author)**

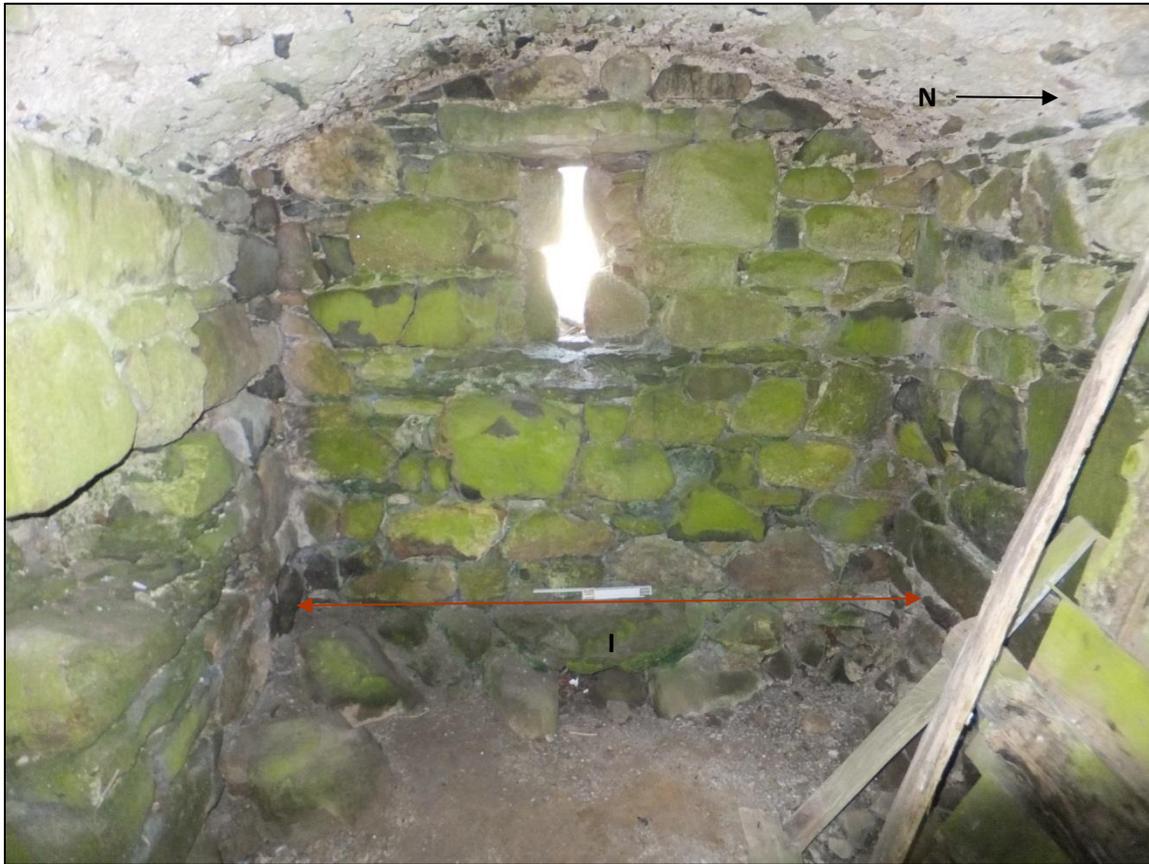
Figure 16. Possible drain below loop in W elevation.

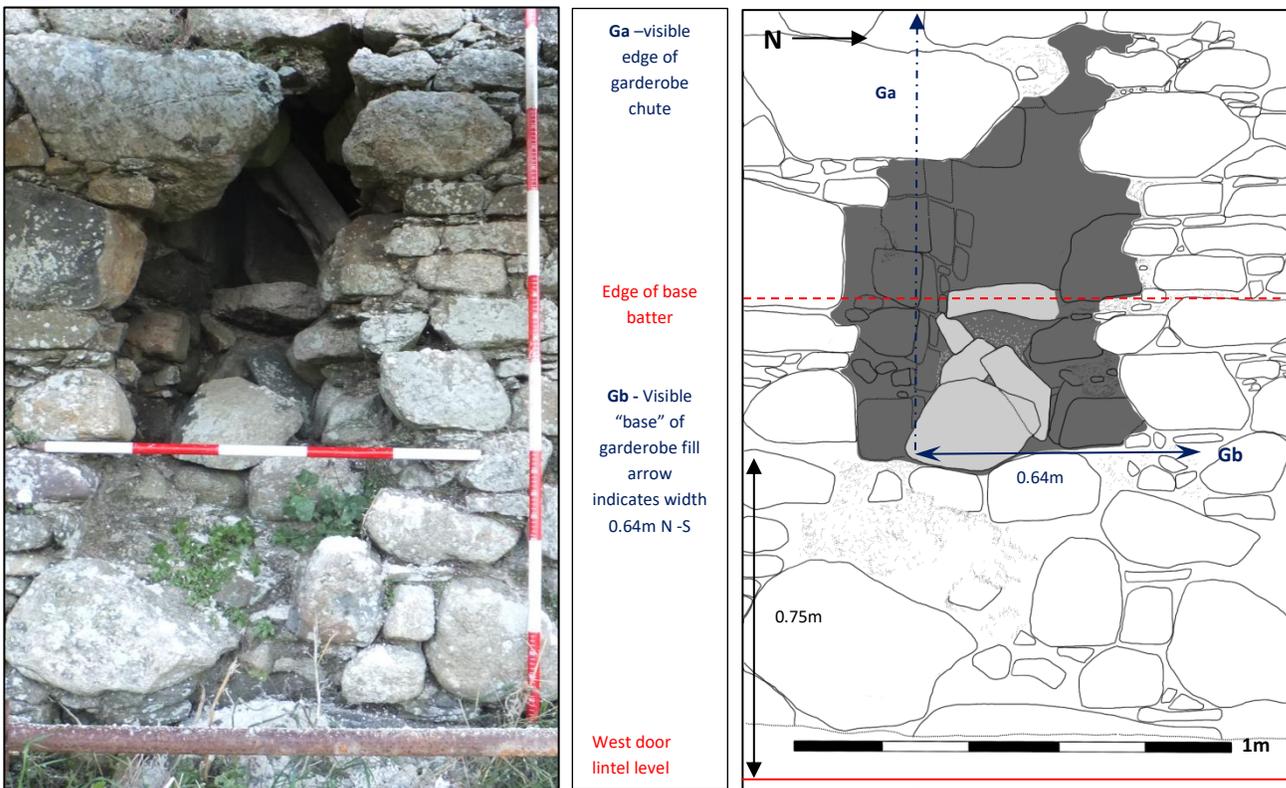
<sup>4</sup> This opening may have been caused by a weakening of the structure as water entered the chute and was unable to drain away, as it was blocked at this level. Once the east face failed/opened and was robbed-out at this point, this weakened the structure of the east elevation along the line of the chute

Figure 17. Scaled and Rectified photo of opening to garderobe chute.

Figure 18. Scaled & annotated drawing of opening to chute.

Scale = 20cm segments.  
(Drawing & Photo's: A. De Volder)

Allowance should also be made for drainage of rain water due to the fact that the current fracture was probably caused by water getting into the structure from the chute which is open to the elements, and the chute being blocked below the level of the current opening in the fracture, and therefore unable to drain water away below.

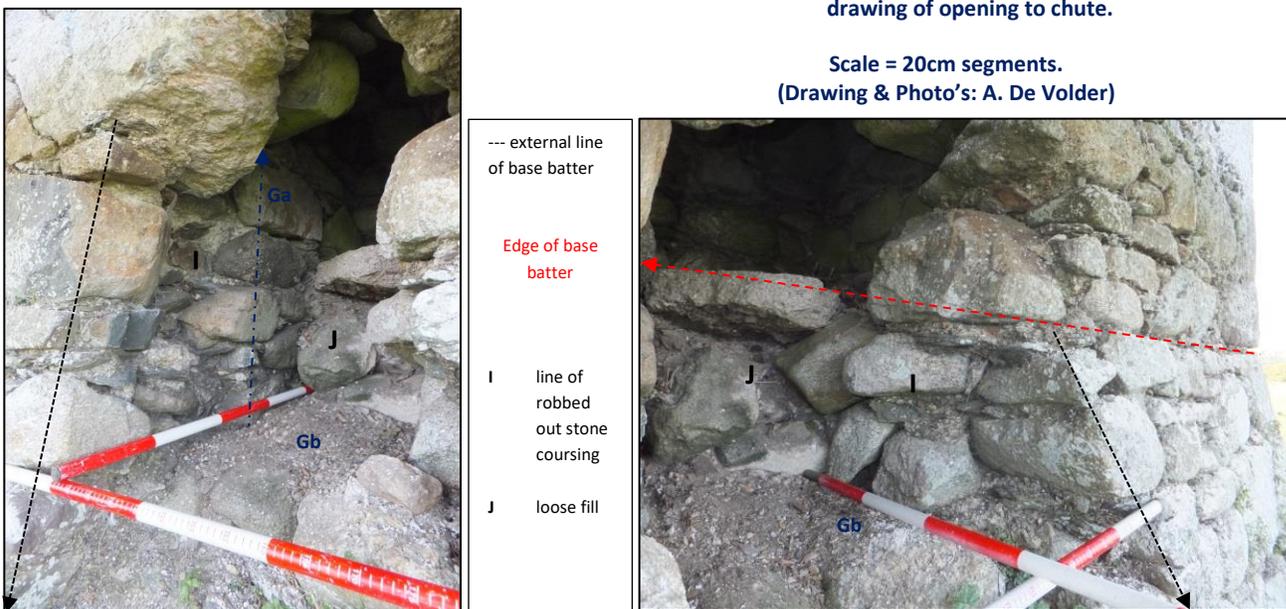
robbed-out – fig. 19 & 20 I. There is no indication of any coursing of the south and north face of the chute angled towards the east elevation of the tower as one would expect if this was a discharge point, but rather it is square and continues down (fig. 12, 13 & 22). While the chute widens from the floors above, and would appear to be favoring an eastern exit, the internal stone coursing doesn't indicate any angle, or slope towards the east face either, to a discharge at this level, as would be expected from a garderobe chute which exits above ground (see e.g. Leask 1995, 83). What appears as stone coursing of the chute, opening/angled towards the east face of the tower (fig. 19 – note line Ga which the edge of the chute) can be explained as stone coursing of the south of the chute's interior face that was tied into the coursing on the chutes interior east face (fig. 19 – at I – location of the robbed-out stone courses of the east face of the chute).

It is most significant that a close inspection of the current chute base (fig. 19, 19 & 20 - Gb) demonstrates that the surface appears to consist of a loose fill - a coarse to fine sand, with small stones and larger pebbles, under the larger loose cement block and stones.

There is no indication of a stone base within the dimensions of the chute itself; it would however appear that an edge to the chute is discernable that continues below the current surface marked Gb.

Outside of this, within the line of the base-batter, this is not the case and the surface appears solid and part of the interior of the base-batter – the fill therefore appears to continue below the visible base level - Gb as currently is within the chute, as does the stone coursing of the chute itself.

Figure 19. Chute opening looking south.

Figure 20. Chute opening looking north.

2. The only way to be certain about where the chute exits would be to excavate the fill of the chute under the appropriate license.
3. A small test pit in front of the E elevation would additionally resolve the question of the location of the chute discharge, which it is postulated lies at, or close to, the ground floor lintel level (Appendix 3, fig. 8; Appendix 7, fig. 17). It is also possible that it continues straight into a "French drain" below the batter, which runs to the shoreline.

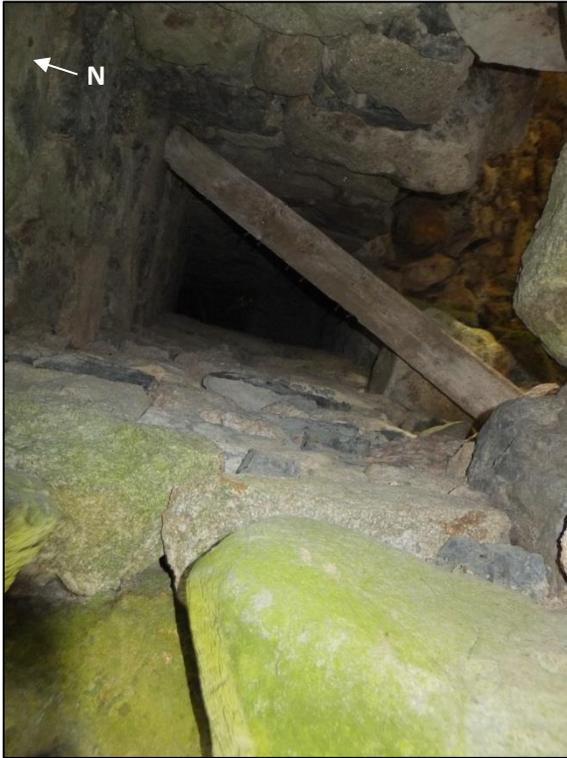
Figure 21. Interior of chute looking up from base batter.

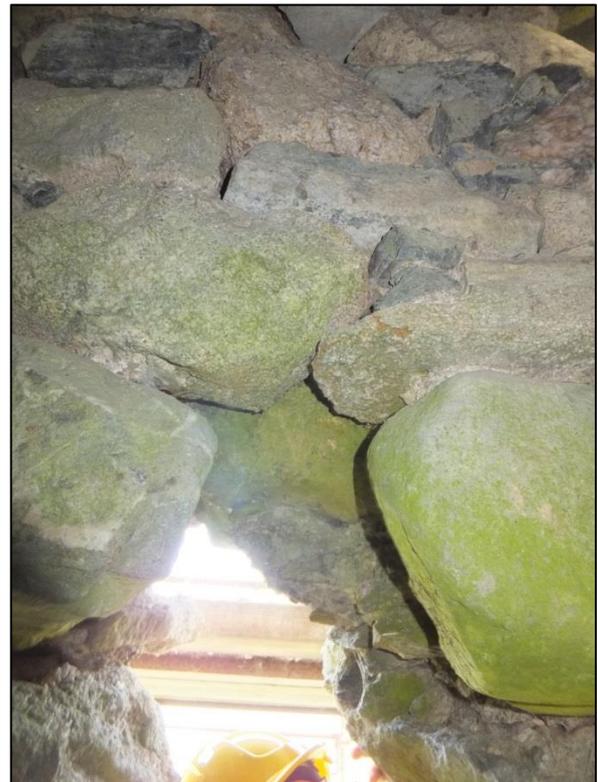
Figure 22. Interior E wall of chute from base batter.

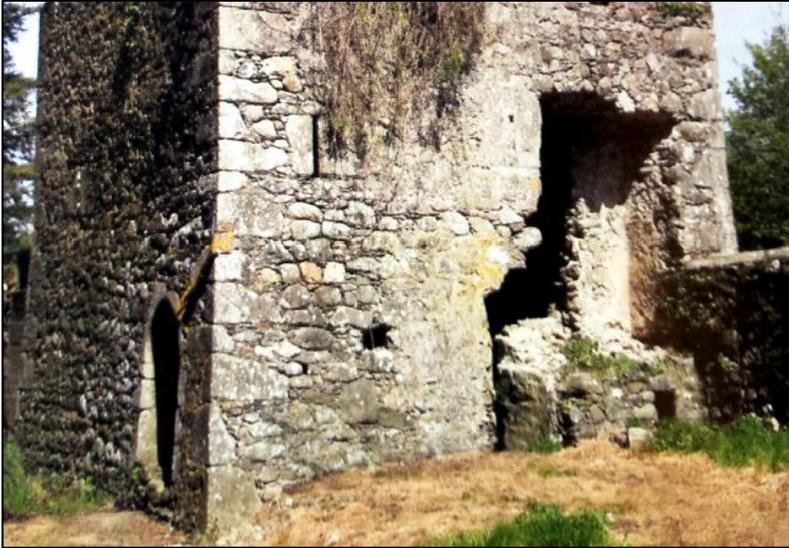
Figure 23. Barrystown Castle (S and E elevations).

Another smaller tower in the vicinity, located at Barrystown (the other side of the estuary - opposite Clonmines), which survives to the above ground floor vault level (fig. 23), had an intramural chute which does not discharge above the ground floor door-lintel height. The chute is contained in the NE corner of the wall, as at Clonmines (fig. 24 – A), and appears to continue straight down to the base.

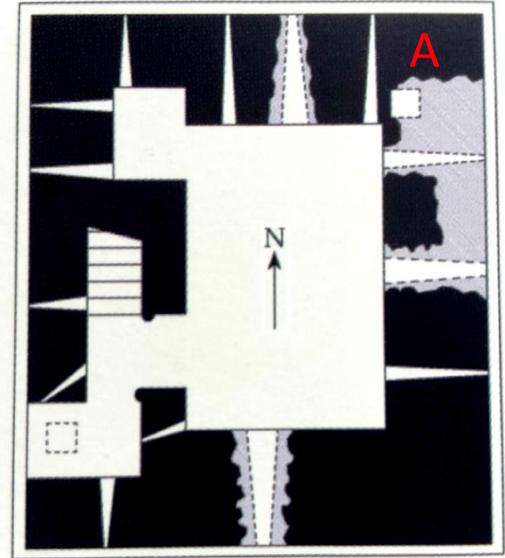
Figure 24. Barrystown Castle ground -floor plan.  
(Colfer 2013, 169)

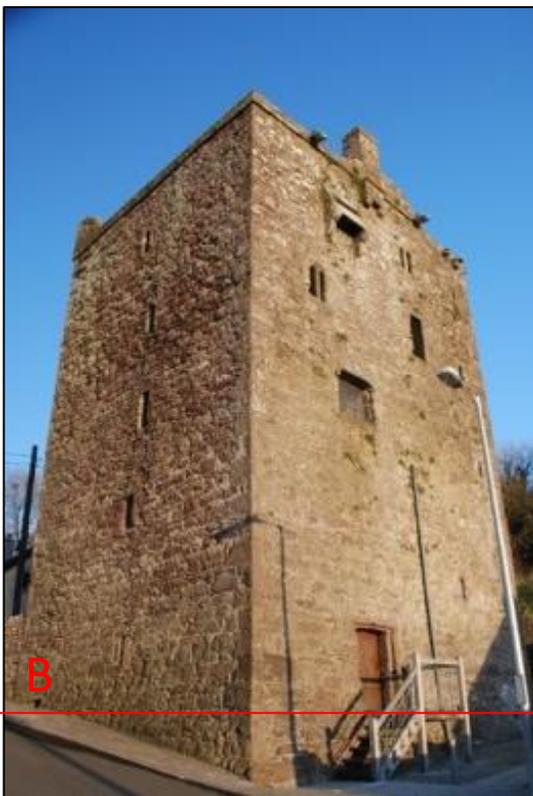
Figure 25. Ballyhack Castle.  
(S - SW elevation. Photo: A. De Volder)

Where the chute discharge is visible in the base batter, rather than going straight down to a drain, these appear to be adapting to local topography, rather than a deliberate sighting of the discharge high enough to make it visible in the elevation/batter. An example of this would be at Ballyhack castle, though it must be noted that this discharge is at the level of the entrance door lintel level. (fig. 25 & 26 – B).

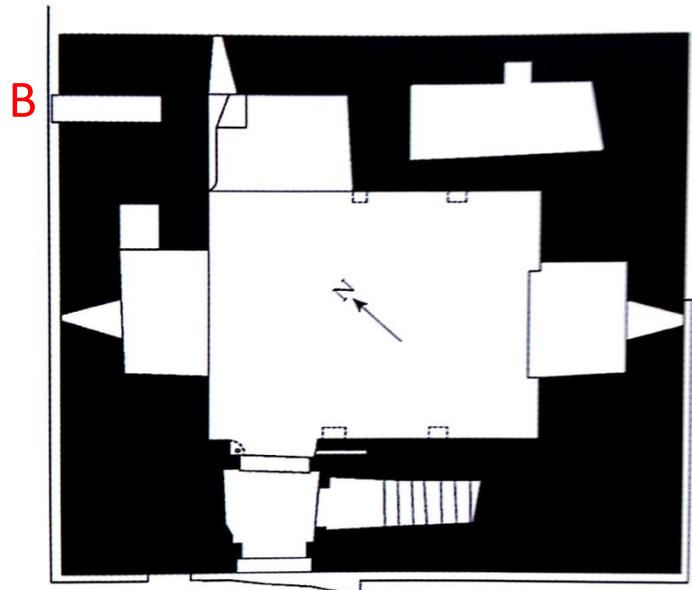
Figure 26. Ballyhack Castle ground-floor plan.  
“B” indicates the position of the chute, and chute discharge (Colfer 2013, 169).

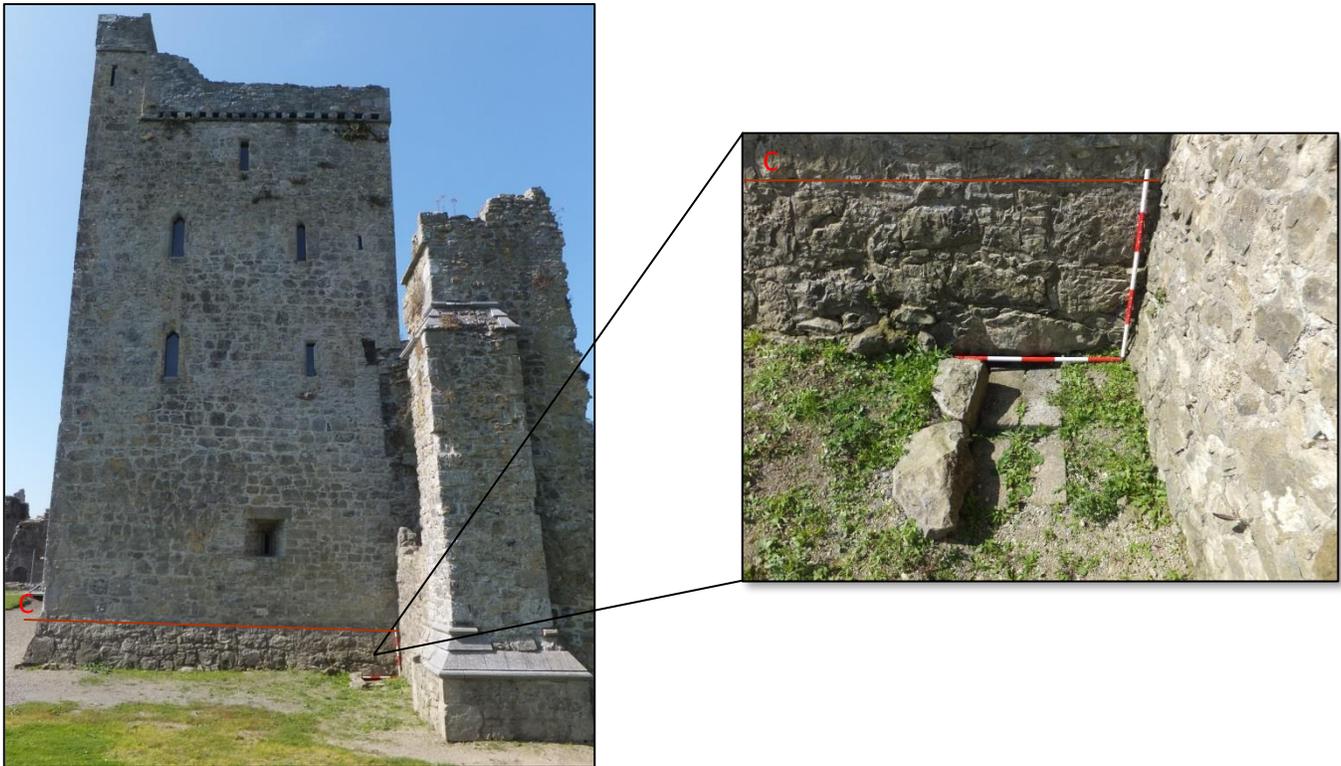
An example of a tower-house that has been excavated in the South East and shows a garderobe chute that exits to a drain, with a lintelled discharge at the base of the batter below the level of the entrance door-way, is at Kells Priory in Killkenny, and is shown here for illustrative purposes (fig. 27).

Figure 27. Kells Priory (Kilkenny), 15th/16th C (?) "Priors Tower" – East Elevation.

An example of a chute discharge, and drain, which has been excavated. Enlarged image shows the chute discharge (with lintel) and drain at/in the base of the batter. "C", and the red line, indicates the approx. level of the door/entrance lintel level (Clyne 2007, 60-63, 95-99). Photo's: A. De Volder.

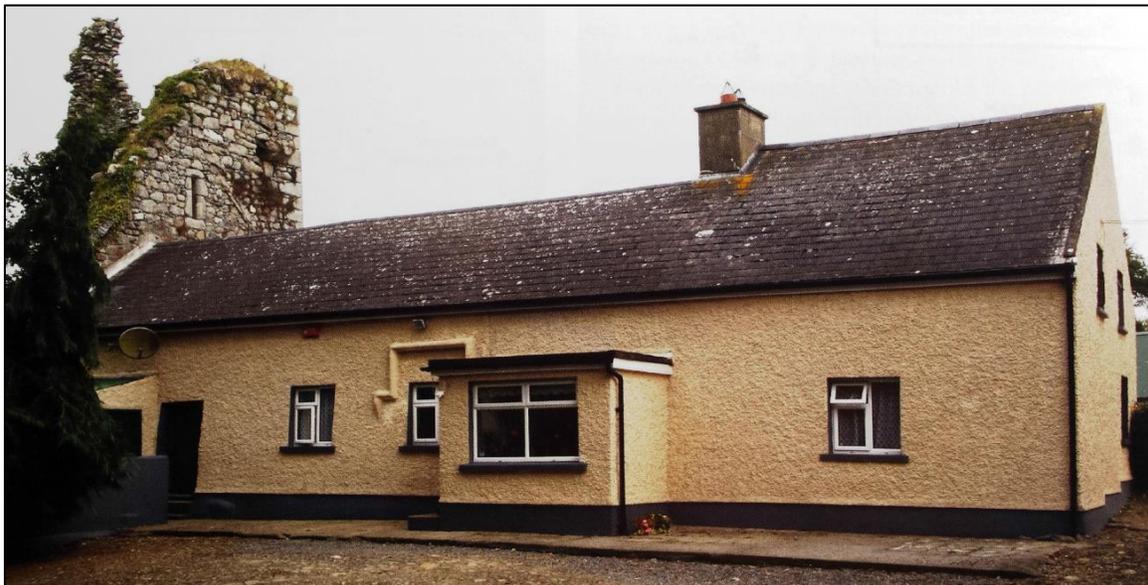
Figure 28. Kilcavan castle - looking from the S - SE, showing the E wall of the tower (Colfer 2013, 178).

When looking at tower-house's in the vicinity, such as at the probable medieval manorial center of Kilcavan (fig. 28) - which was possibly connected to the FitzHenry family, as was the tower-house at Clonmines – this tower does not show any signs of a garderobe chute exiting above ground level, though unfortunately much of the tower is in ruins (*it stands to approx. 4 story level?*). There is still a dwelling attached to the east wall of the tower as well.
