Clonmines Friary Preliminary Report

*Augustinian Friary, Clonmines, Preliminary
archaeological survey report*

SMR No's: WX045 – 012002
WX045 – 012003
WX045 – 012004
WX045 – 012011

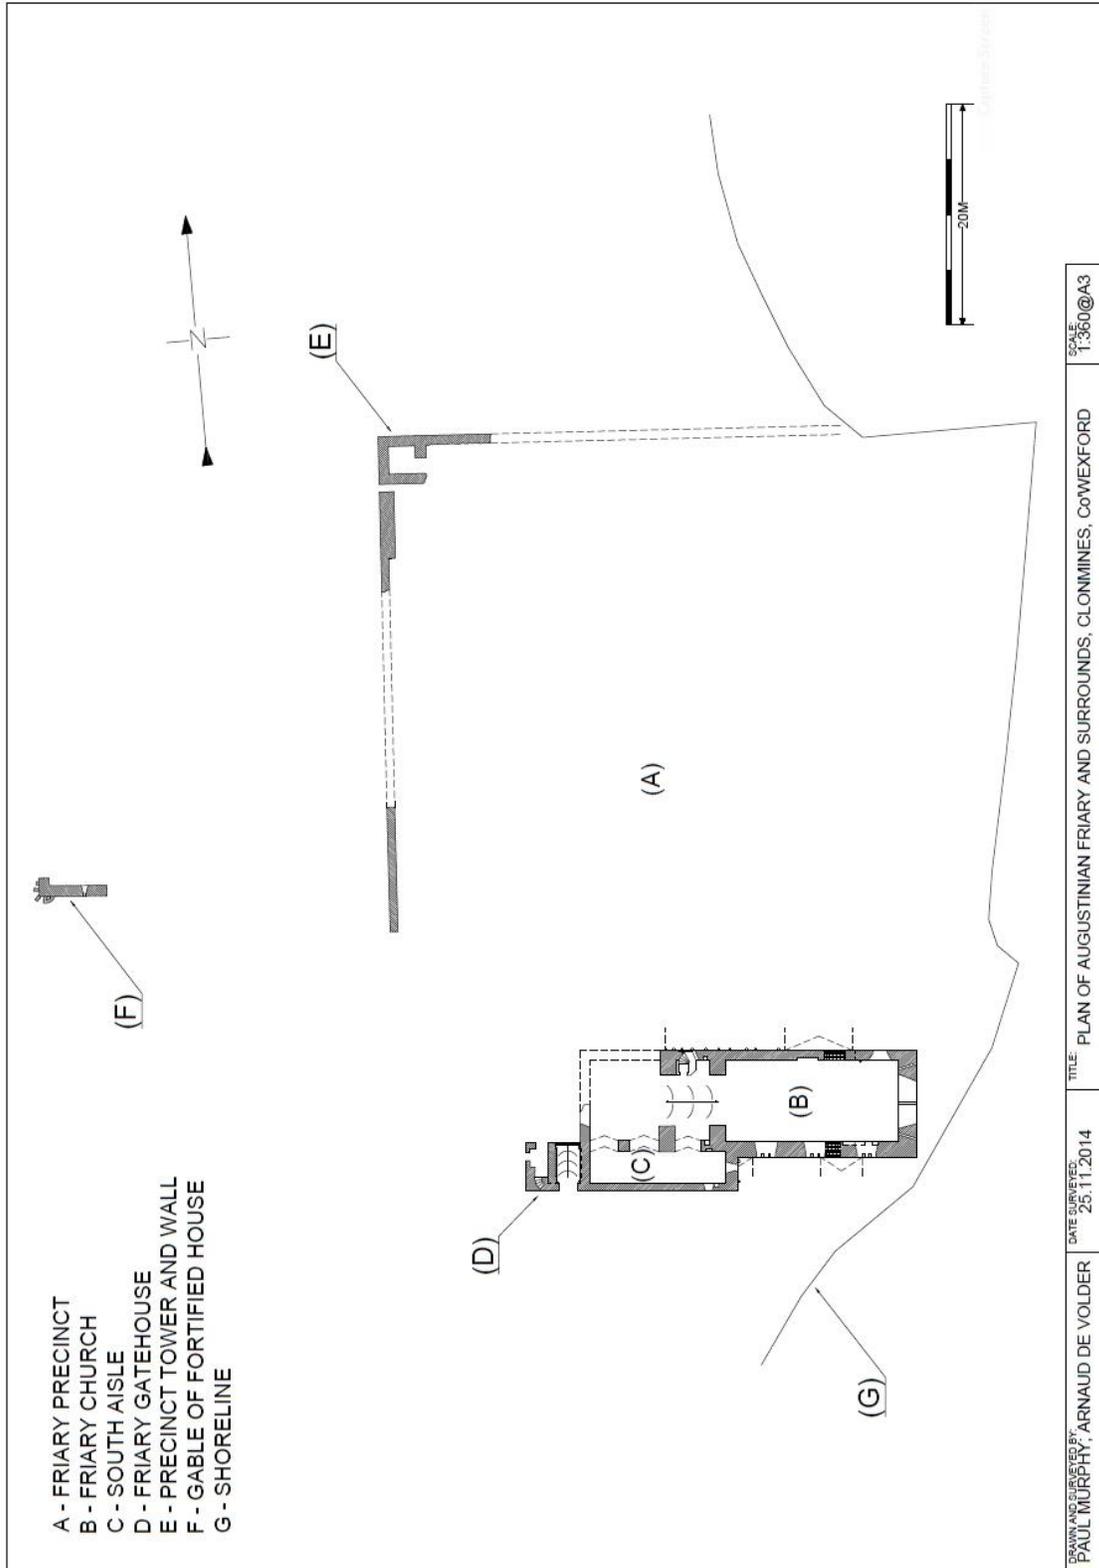
Figure 6. Plan of Friary church and gate-house

The internal dimensions of the nave measure 12.2m E-W by 7.2m N-S. (fig. 6) and consists of three bays (1 – 3, west – east) with unmoulded arches and rectangular piers chamfered at the corners. Some of the chamfered moulding on the piers has evidence of diagonal tooling on the quoins (fig. 35). The building material is a mix of rubble stone masonry (as in the rest of the friary church and complex) and includes granite, sandstone, quartzite and shale. Some of the quoins and mouldings are possibly a creamy yellow Caen or Dundry stone. It is apparent that some of this stone is reused as it has mouldings/chamfers placed to the interior of the arches (figs. 29, 30 & 35) in positions that would not have been visible. The chamfered quoins of the piers finish in simple elongated (pyramid shaped) stops at the base of the piers, which has simple moulding (fig. 28; 37).

A later crossing tower was inserted into the eastern end of the nave. The entire north wall of the nave up to the north-western support of the crossing tower (fig.6) has been demolished. The northwest nave wall has also been destroyed. The west wall of the nave had a large elaborate decorated style window according to the engraving in Grose's *Antiquities* (Grose 1791 vol. 1, pl. 122, 44-5). Quoins of red sandstone survive in what remains of the interior arch of the west window, along with a section of fleuron moulding positioned above them (fig.25).

The south aisle has a robbed out piscina and a blocked window towards the east end of the south wall (fig. 6), a partly destroyed east window (with a pointed arch that is plank centred), and an ambry on the north wall (fig. 6). These features indicate the former location of a chapel within the south aisle.

The exterior south elevation (fig. 31 & 8) of the aisle shows a break in the masonry to the west, which indicates a different phase of construction as noted on the plan (fig. 6). The exterior of the east elevation (fig. 9) of the south aisle appears to be tied into the south chancel wall as indicated on the ground plan (fig. 6). There are also two corbels located on the exterior east elevation.

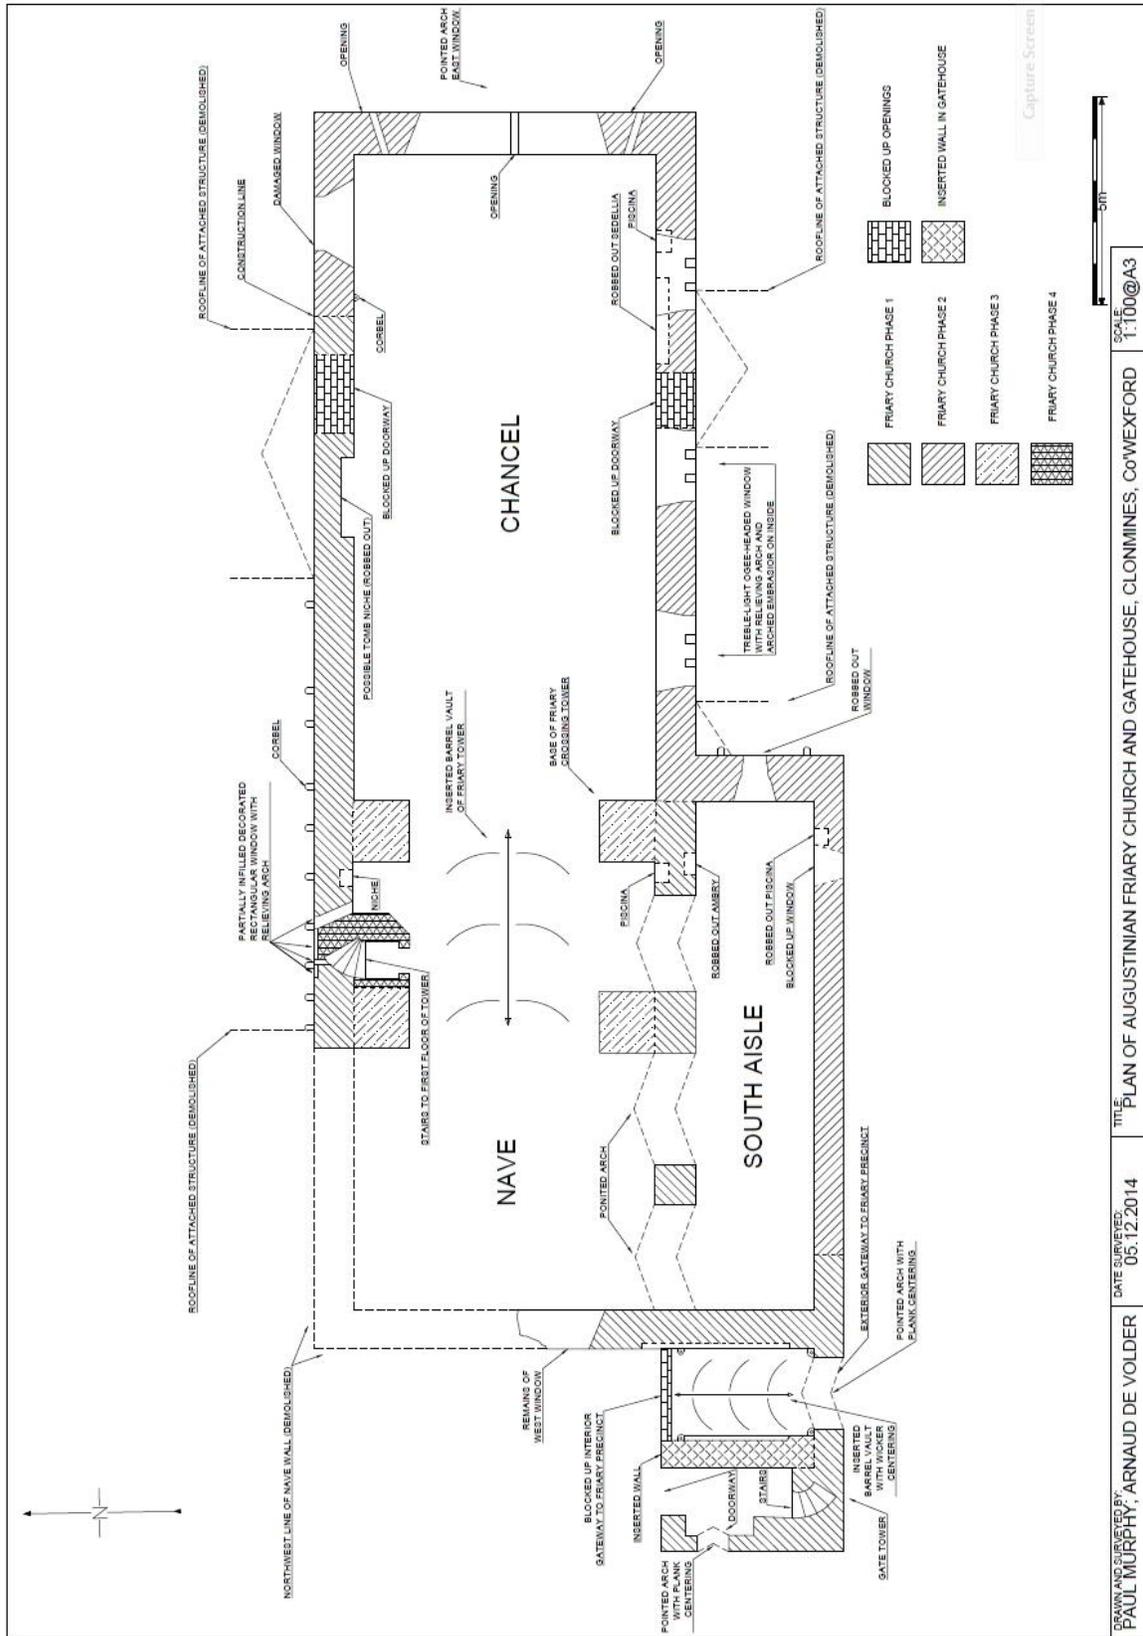
Figure 7. Exterior west elevation

The west wall is approx. 0.90m - 1.10m thick and it is composed of string-coursed slate spalls and large stones (rubble masonry consisting of granite, conglomerate and sandstone) (fig.26). At the exterior of the west wall (fig.7) there is a gate-house at the south corner, which is only partly tied in. A portion of the exterior west wall was removed to take the support of an arch and vault within the gatehouse (fig. 7 - marked in blue on elevation). This may have weakened the lower section of the west wall which appears to be disturbed (fig.26).

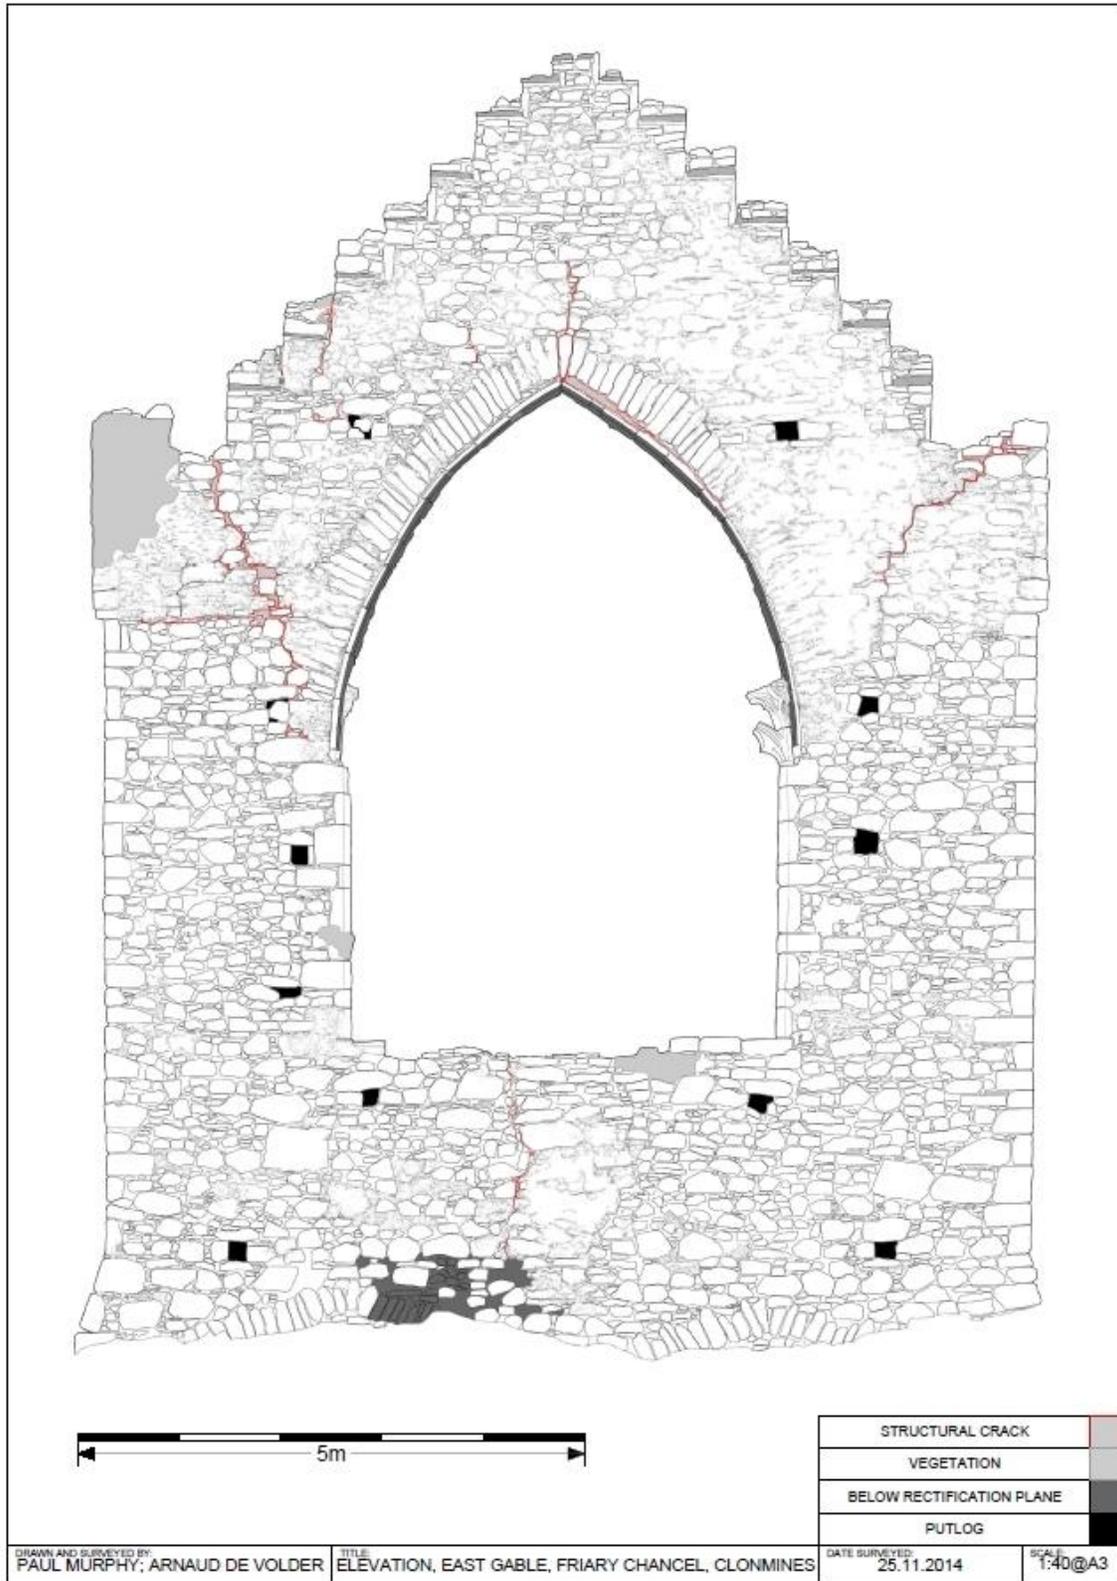
Figure 10. Exterior east chancel elevation

The chancel (int. dims. 15.55m E-W; 7.2m N-S) has a destroyed east window (fig. 10 & 32), three damaged three-light ogee-headed windows in the south wall (fig. 11), and a destroyed/robbed out pointed arch window in the north wall (fig. 34 & 12). The south and east elevations of the chancel are supported by a series of arches visible at foundation level which spring from a series of masonry piles below ground level.

The east window has a plank centred pointed arch (ext. dims. 4.19m wide x 6.2m high). It has finely punch dressed granite chamfered quins. On the exterior of the east wall there is granite hood moulding that finishes in badly eroded stops. There are two fragments of finely dressed limestone tracery that remain in situ, indicating that the window had a high quality decorated

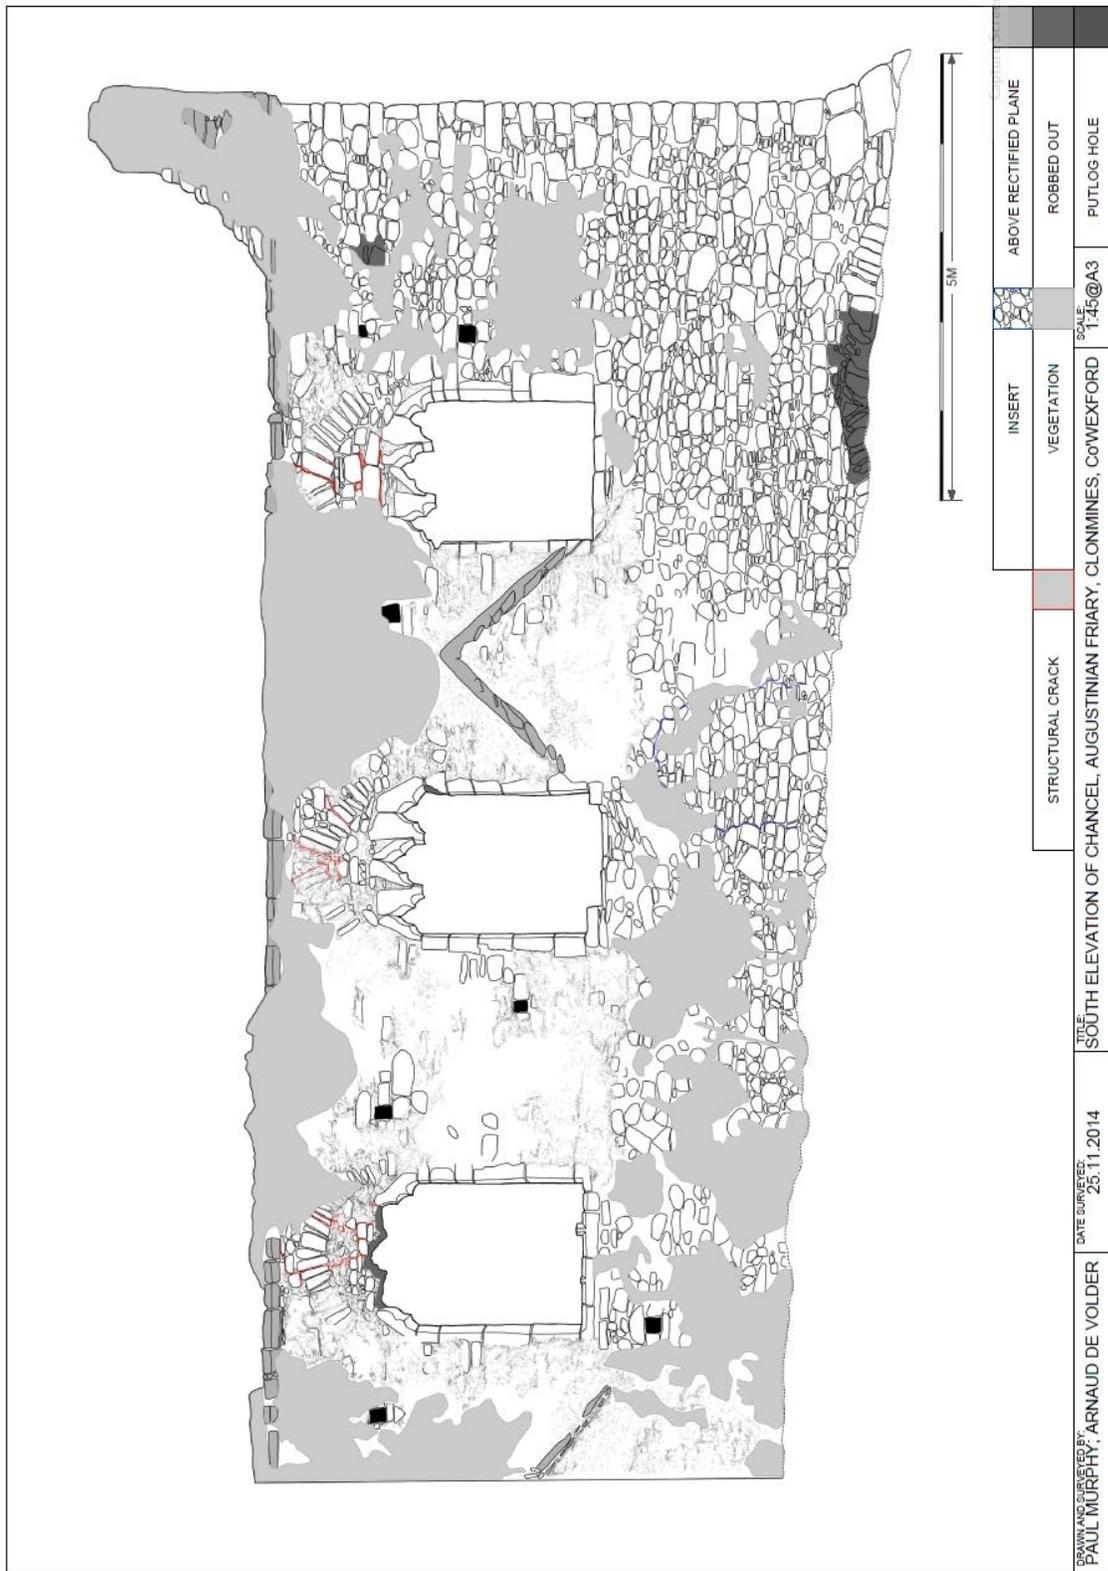
Figure 11. Exterior south elevation

The south side of the chancel is dominated by three large treble light ogee-headed windows with embrasures (fig. 11). There are relieving arches over the moulding. The ogee shaped heads are cusped with the central light slightly higher than those to the sides. The central mullions have all been robbed out and the ogee heads at the western side are missing. There was a structure attached to the exterior of the south chancel wall as indicated by a ridgeline located between the two eastern most windows (fig. 11). Below the ridgeline and partially below the central south chancel wall window there is a blocked-up doorway (fig. 11). This doorway is also visible on the interior of the south chancel wall adjacent to the sedilia (fig. 33).

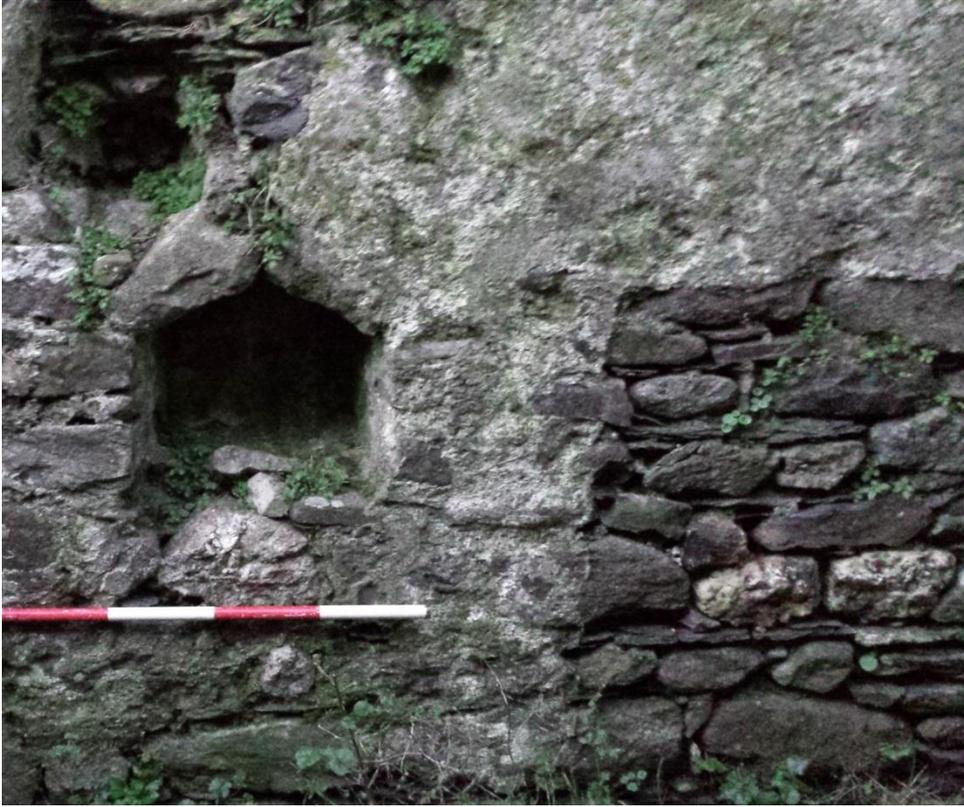
Figure 28. Piscina - East nave arcade pier

On the south side of the east end of the nave, within the corner of the southeast tower support and southeast arch support of the third bay, is a granite ogee-headed piscina with a damaged carving (in Caen or Dundry stone?) above its centre-point (fig. 28). On the north wall, opposite to the piscina mentioned above, is another possible robbed out piscina (fig. 6). These indicate the locations of two altars which would have stood in front of the chancel screen where the nave terminates.

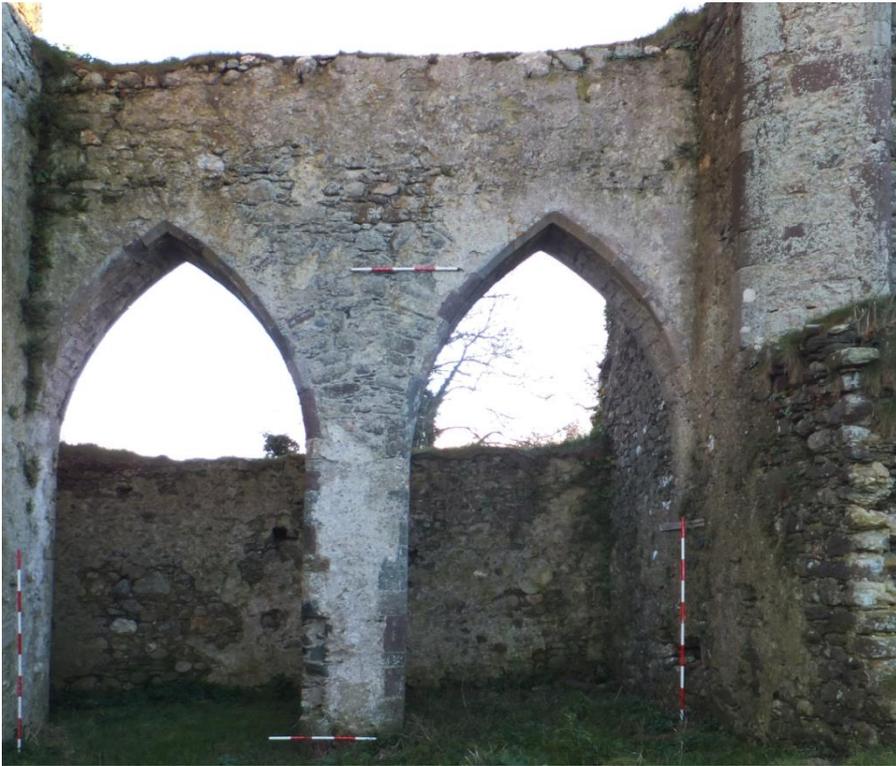
Figure 29. West nave arcade - north elevation

There is an aisle (12.2m E–W by 2.85m N-S) located to the south of the nave. The aisle and nave are separated by the row of piers of the three bays of the nave, consisting of the plank centred pointed arches and simple rectangular piers, as noted above (figs. 29 & 30). The aisle had a pitched roof, the evidence for which is seen in a ridge line on its southern wall (fig. 8) and a row of four large corbels located just below the top of its northern wall. Beneath the row of corbels there is a line of joist holes (fig. 31).

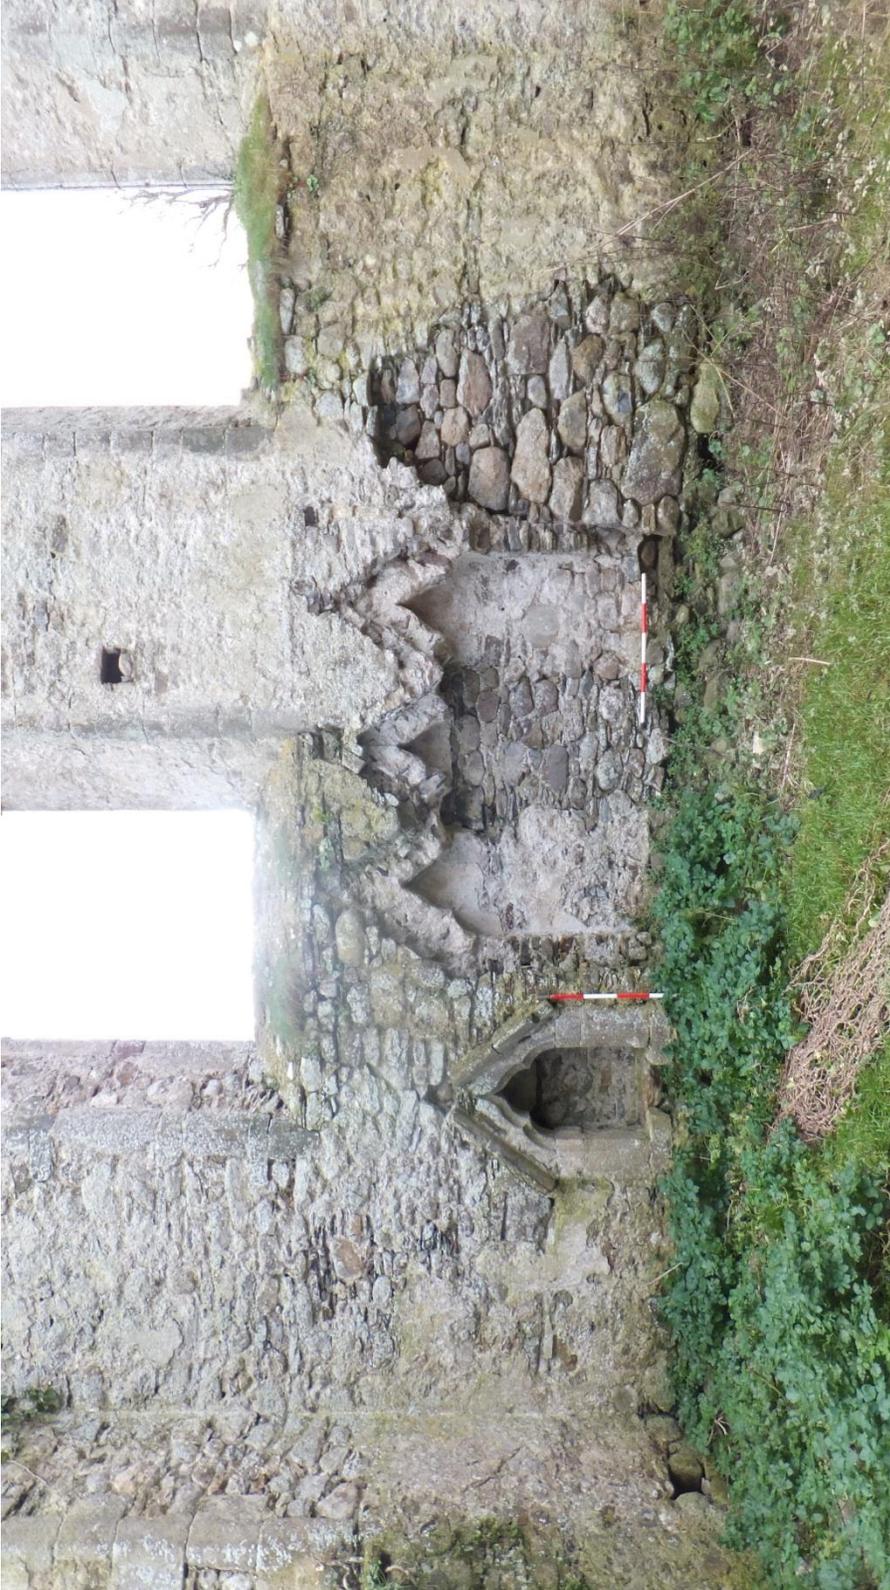
Figure 33. South side of chancel interior

There is a robbed out triple sedilia in the south wall (fig.33), which would have had cusped ogee heads similar to the windows in the south wall and the surviving piscina located adjacent to it. The piscina is of dressed granite with rolled and filleted hood moulding.

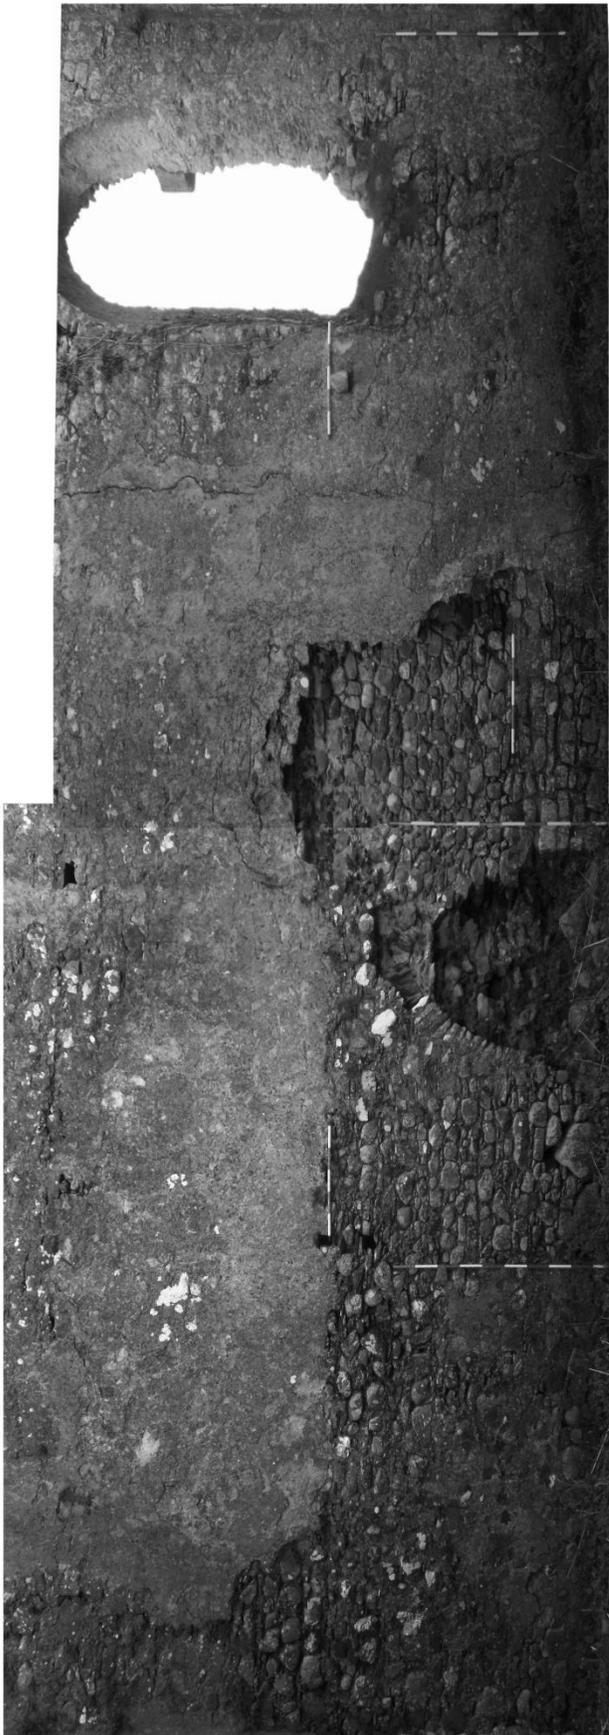
Figure 34. North wall of chancel interior

A single robbed out pointed (possibly plank centred) window exists in the north east wall of the chancel (figs 34 & 12). The window is approx. 2.10m wide with an interior arched embrasure. There is one dressed chamfered window quoin remaining in the exterior of the window (fig. 12).

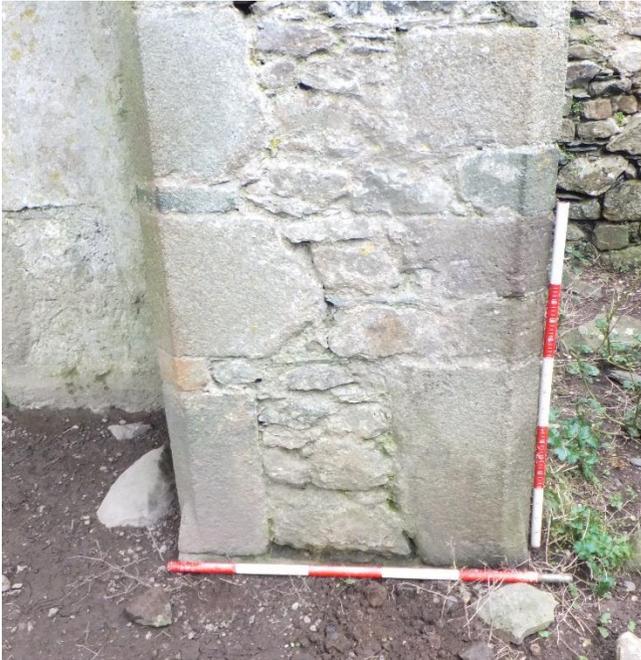
Figure 37. Elongated chamfer stops and moulding at the base of the nave arcade pier (east end of the third bay)

The elongated chamfer stops of the nave piers (fig. 28; 37), and moulding's at their base (fig. 28; 37), are very similar to those found in the nave of Tintern Abbey, County Wexford (fig. 38), to which a date of c. 1300 is attributed, based on comparisons to the architecture at Baltinglass Abbey, County Wicklow (Stalley 1987, 267, fig. 67; Lynch 2010, 18, Pl. 28). These types of simple elongated chamfer stops were common in the thirteenth and fourteenth centuries (Lynch 2010, 39). This raises the interesting question of whether the similarities observed in the architecture of the nave of the friary church at Clonmines and at Tintern Abbey (County Wexford) are indicative of the building works having been done at the same time, by the same stone masons, or within a few years of each other. The naves in both churches are somewhat austere and plain with unmoulded arches, rectangular piers chamfered at the corners, simple elongated stops, and simple moulding at the bases.
